4. TITLE (and Subtitle) WILLOW CREEK DAM SPILLWAY AND STILLING BASIN AT HEPPNER, OREGON Hydraulic Model Investigation		5. TYPE OF REPORT & PERIOD COVERED

WILLOW CREEK DAM
SPILLWAY AND STILLING BASIN
AT
HEPPNER, OREGON

Hydraulic Model Investigations

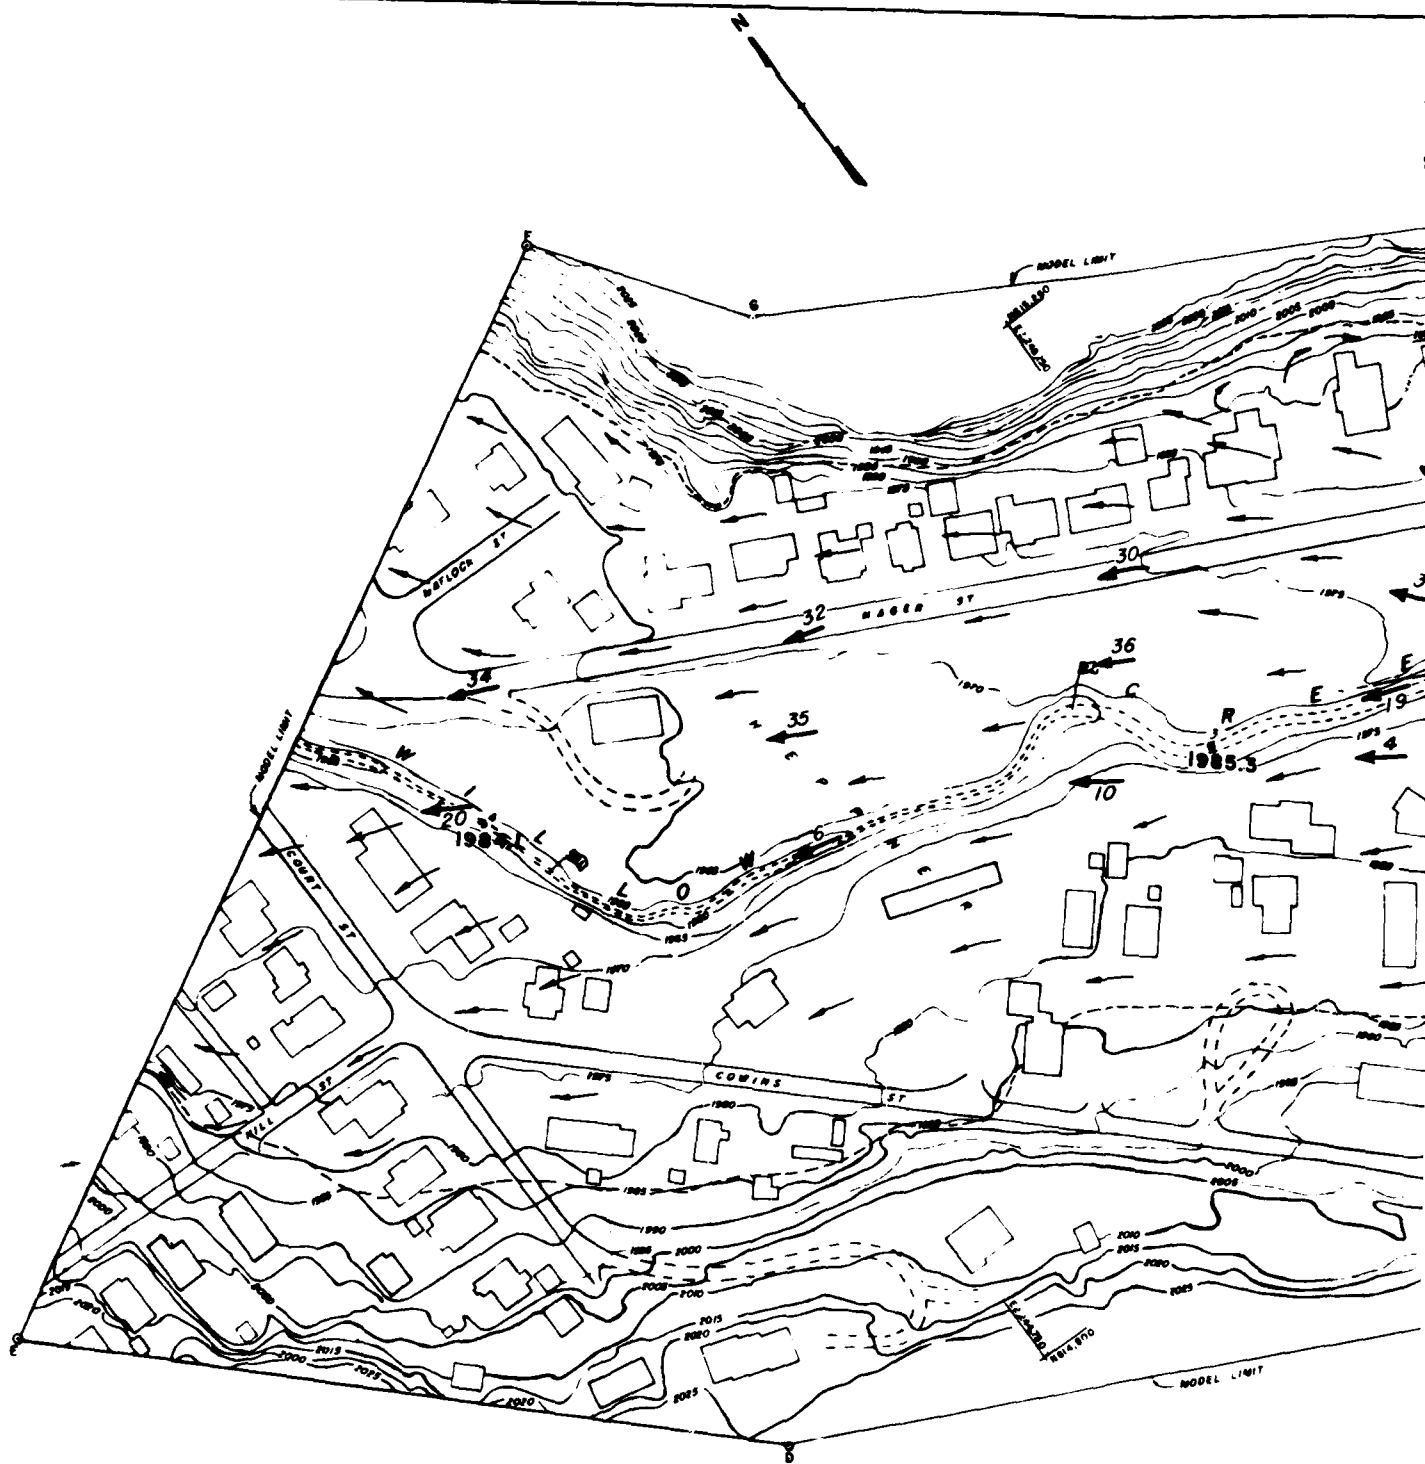
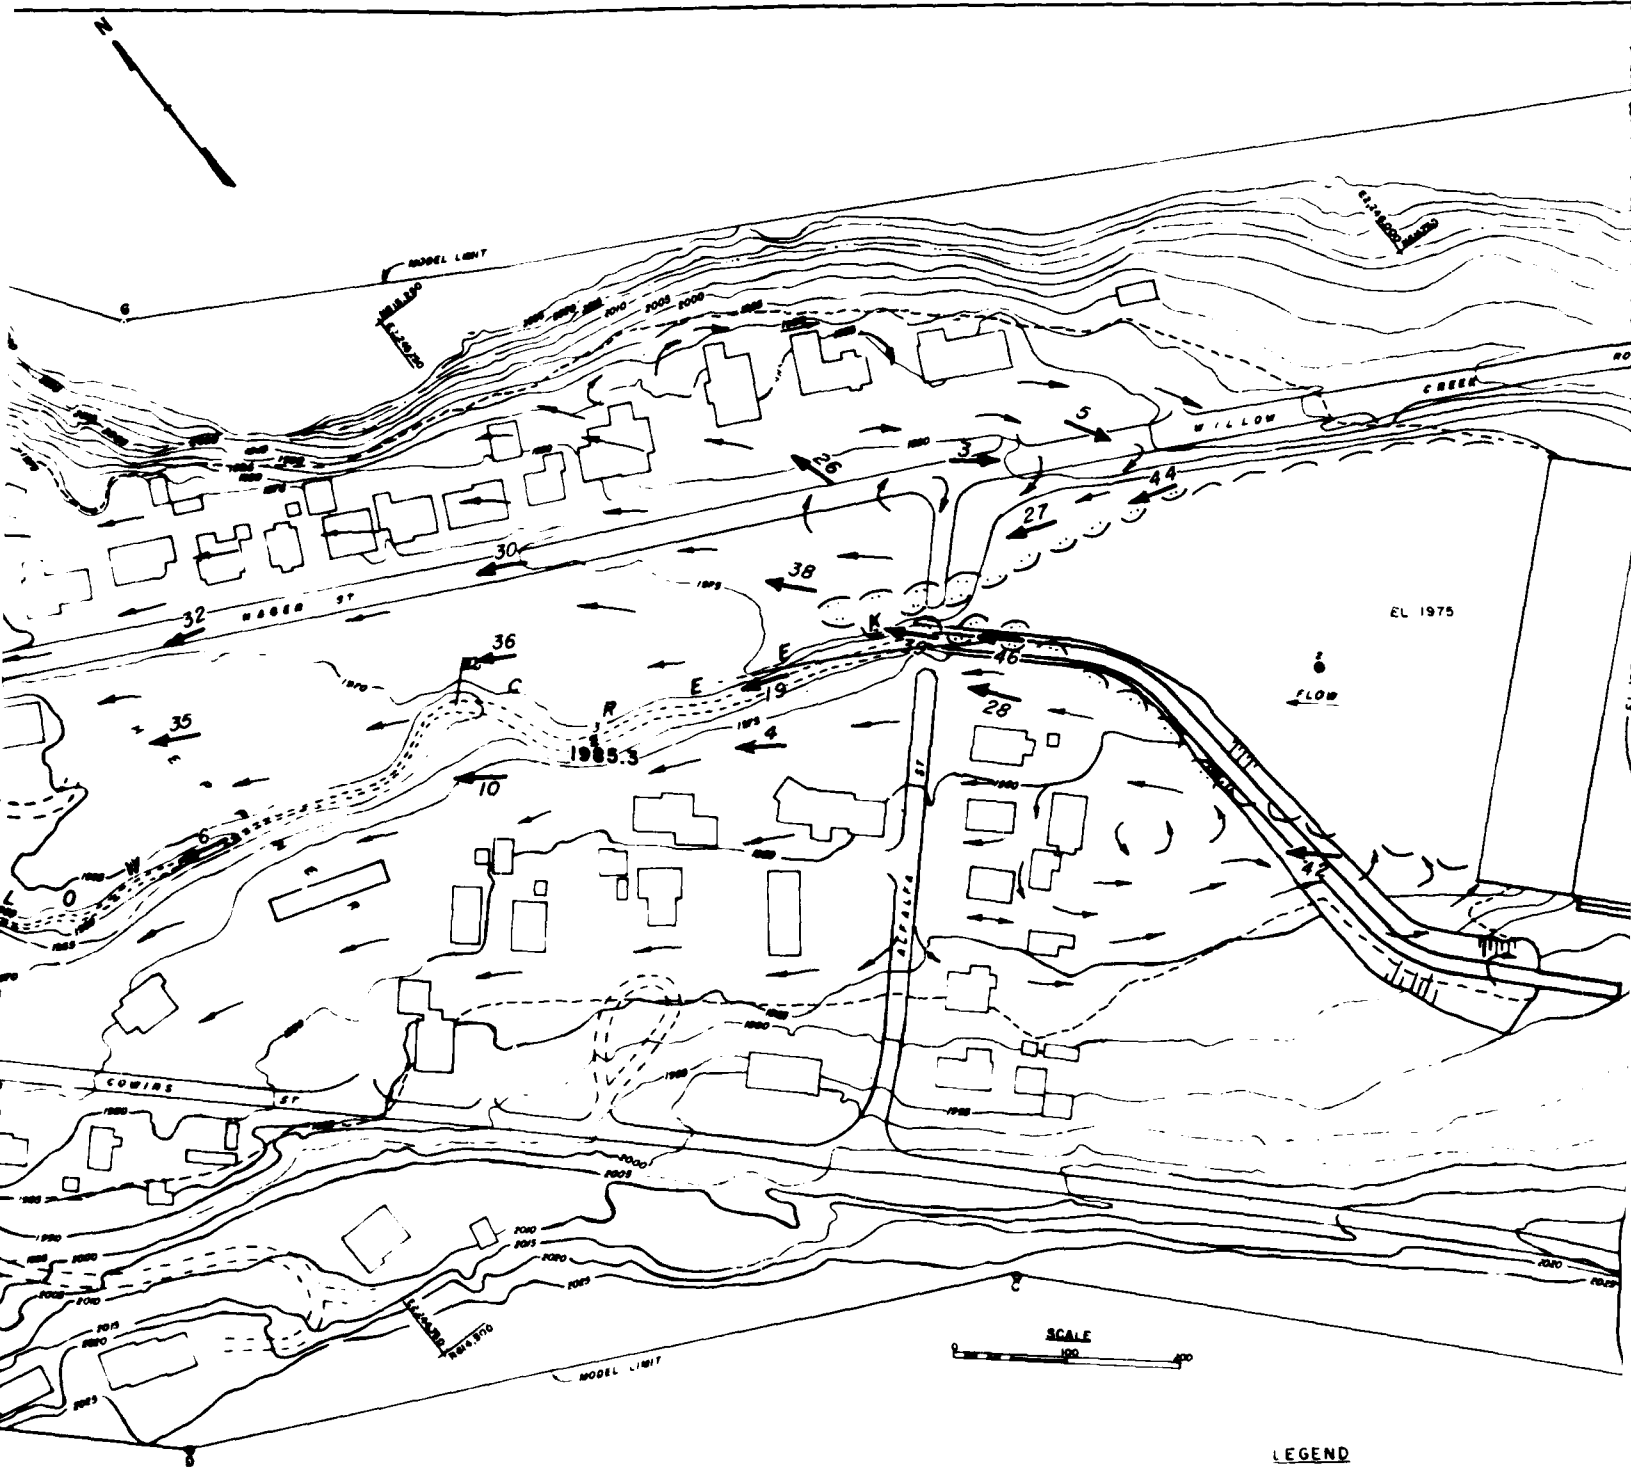
FLOW CONDITIONS
 REGULATED SPILLWAY DESIGN FLOOD
 DISCHARGE 91 700 CFS

STILLING BASIN FOR 18000 CFS WITH SCOUR
 AND NO END SILL

17. Flow conditions assuming the end sill washed out and the area immediately downstream scoured to rock are shown on plates 17 through 19 for the greater-than-design-discharges of 24,000, 45,000, and 91,700 cfs. Flow swept out of the basin and a hydraulic jump formed in the scoured area downstream (photographs 32 and 33). With 91,700 cfs, the jump was at Alfalfa Street (photograph 34). Velocities at the jump were as high as 46 fps.
